Technical Report ARAED-TR-93016

FIELD ARTILLERY PROJECTILE PALLET (FAPP) PROTOTYPE

Alvin K. Lew

October 1993

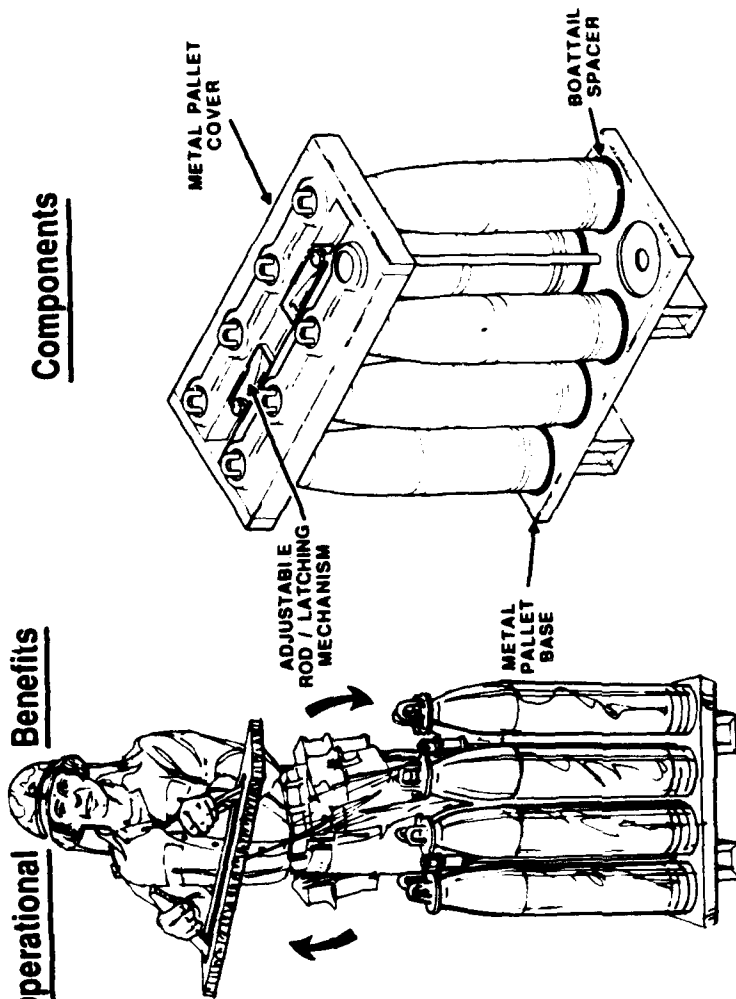
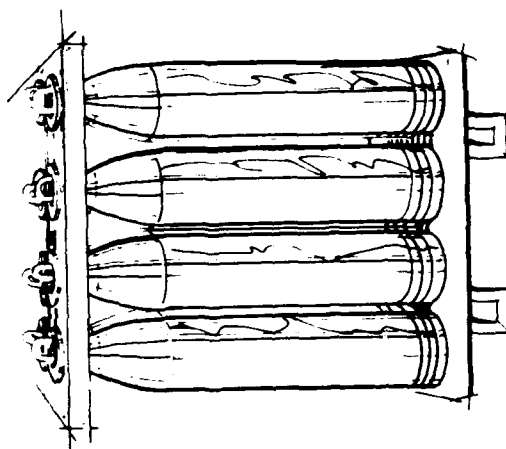
Figure 3. 155-mm projectile packaging improvement program

Features

- ELIMINATE BANDING
- IMPROVED DURABILITY
- NBC DECONTAMINABILITY
- NON FLAMMABLE

Operational Benefits

- ONE STEP EASY ACCESS TO A CLEAN ROUND
- EASY REASSEMBLY WITH FULL OR PARTIAL LOAD
 - NO LOOSE ROUNDS
- IMPROVED MARKING
- NO NEED FOR SPECIAL TOOLS

The objective of the FAPP program is to replace the existing wooden pallet [fig. 1, ARDEC drawing 8837839] for 155-mm projectiles with a steel pallet [fig. 2, ARDEC drawing 12926862]. The wood pallet has several design deficiencies such as poor structural integrity, inability to be nuclear, biological, and chemical (NBC) decontaminated, flammability, and the use of banding to constitute the pallet load. This new pallet is required to be structurally stronger, require reduced maintenance, replacement, be NBC decontaminable and nonflammable, allow easier quicker access to projectiles, and allow for repalletization of ammunition in either full or partial loads without banding or special tools (fig. 3).
